Results of the application of the contact potential difference method to monitor NPP process equipment

Abstract. The paper presents the results of nondestructive testing of-process equipment of nuclear power plants a welding unit for the collector of steam generators PGV 1000M, the hull penetration and surfacing of the process pipe performed in the factory. The purpose of the study was to justify the possible use of contact potential difference at the stage of technological assembly and control of welded joints of steam generators in the factory, as well as to determine the prospects for using this method in operating conditions of process equipment.

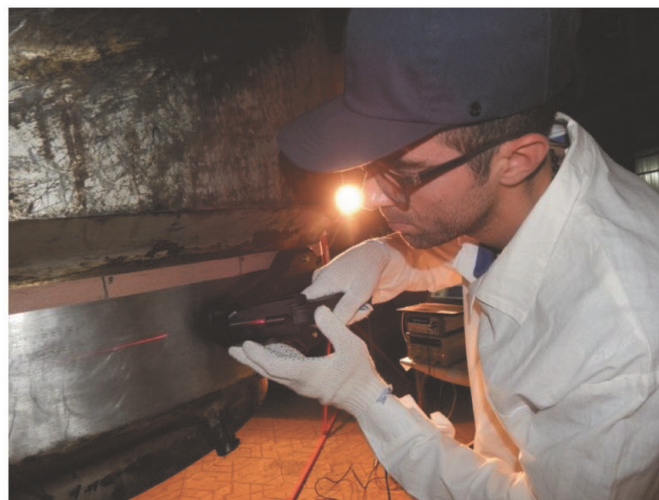
Figure 1. Manual CPD measurements of the input and output pipes in steam generator at the places where they were welded to the corresponding collectors.

Defects detection in welded joints of two steam generators PGV 1000M was performed using the EDSS-1RD rolling sensor (figure 1) and corresponding potentiograms were constructed. Figure 2 (a) shows distribution of potentials over the surface. The x-axis of the potentiogram displays the distance along the measuring tracks. The y-axis shows the track number. The detected inhomogeneities are distributed mainly in the upper and central parts of the welded joints.

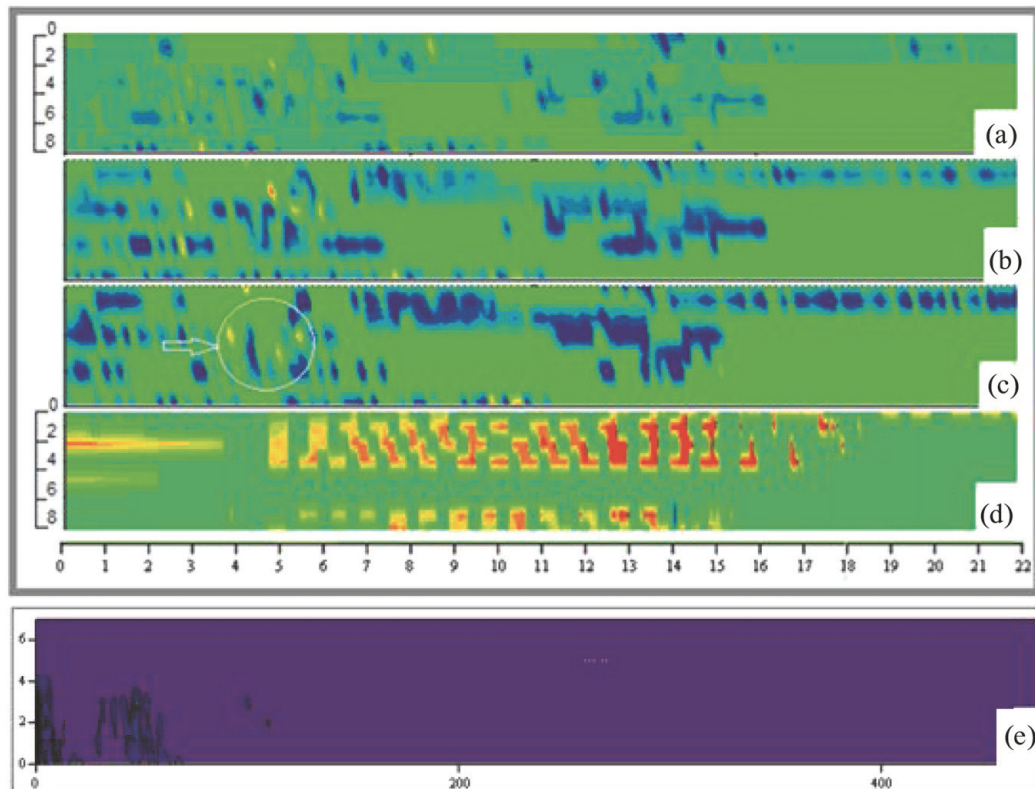
Figure 2. Surface potentiogram (horizontal scan) of hot collector welding joints to the steam generator body, constructed for different values of structure level signal (SLS): (a) 4.77; (b) 5.046; (c) 5.301; (d) results of point-by-point scanning, level 4.155; (e) results for point-to-point scanning. The corresponding scan counts are presented along the x axis.

From visual inspection of welded joints, it was concluded that the potential heterogeneity in the upper part of the welded joints is associated with numerous scratches and deep inclusions of small rust spots less than one mm in size. A small surface defect of about 4 mm was found in section 15 in the central part of the welding joint, which affected the scan result. The results of point-to-point measurements also indicate a large number of surface defects along tracks 1–4 and 7–8. The results of potential distribution for welding joints of the hot collector to the body of the steam generator are confirmed by the results of time-frequency analysis.

In figure 2 (c), the white circle indicates a group of defects detected at high structural levels, which should be classified as inhomogeneities located in the subsurface layer. These defects are shown separately in figure 3, and may be associated with corrosion that penetrates the grain boundaries.

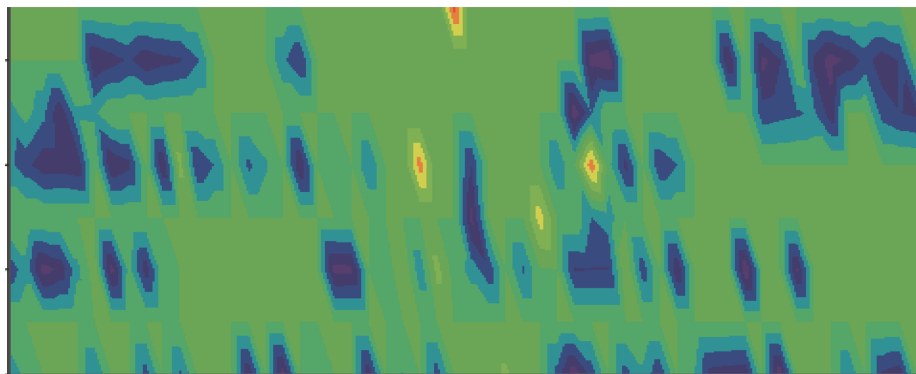
Figure 3. Group of structural imperfections (red spots) $SLS = 5.301$ enlarged in 5th and 6th tracks.

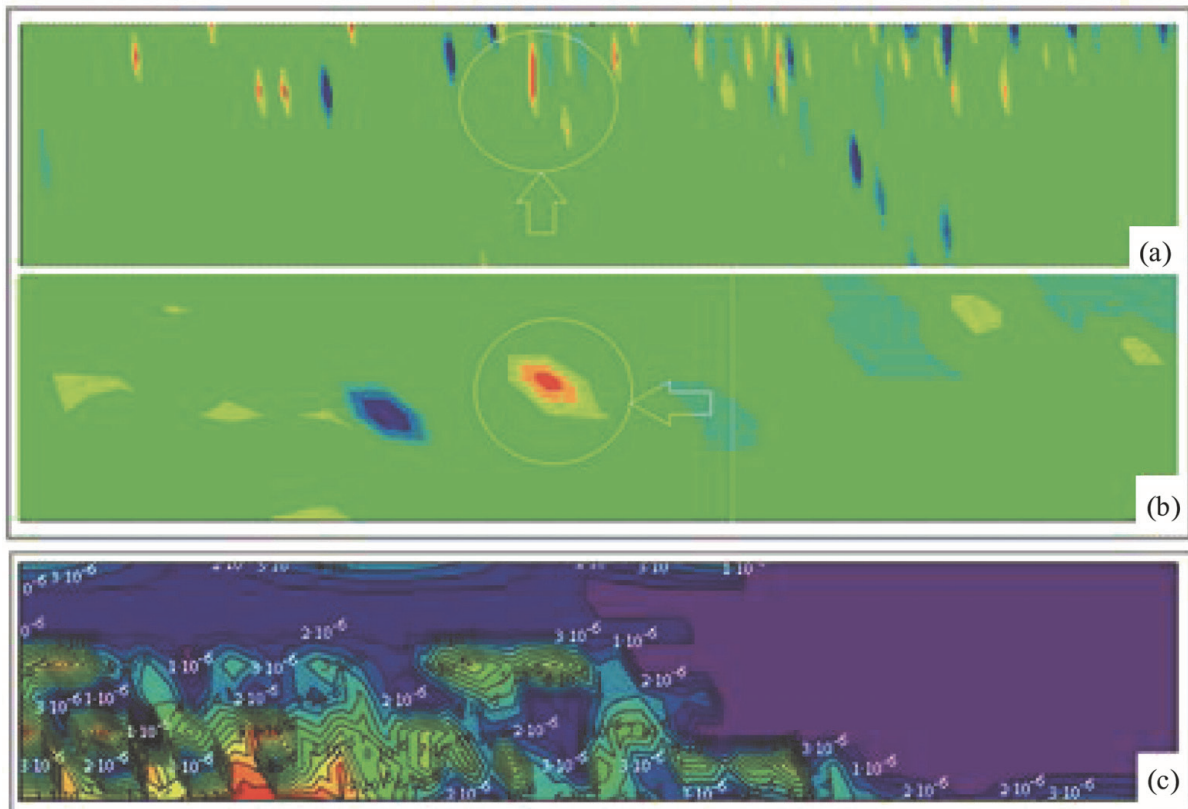
Figure 4. Surface potentiogram of cold collector welding joint to the body of the steam generator: (a) defects detected by the EDSS-IRD flow detector; (b) singularity detected in the control area; (c) the result of DFT

Potentiometric results of cold collector welding joints to the body of the steam generator are shown in figure 4. Attention is drawn to the set of surface defects concentrated along the axis of the welding joints. Visual inspection shows the presence of the same defects as in the hot collector. The potentiogram of these welding joints was constructed at the filtration level of 5.699 (figure 4 (a)). The same figure shows a potentiogram constructed while passing 0.7 A current through the welding joint, where defect was detected in the area of the 4th track (highlighted in a circle and shown by an arrow in figure 4 (b)). The presence of the detected singularity and the accuracy of its location were evaluated using the ultrasonic testing (Ultrasonic flaw detector A1214 Expert). Its depth from the surface of the welding joint was approximately 30 mm. Figure 4c shows the result of applying the DFT.

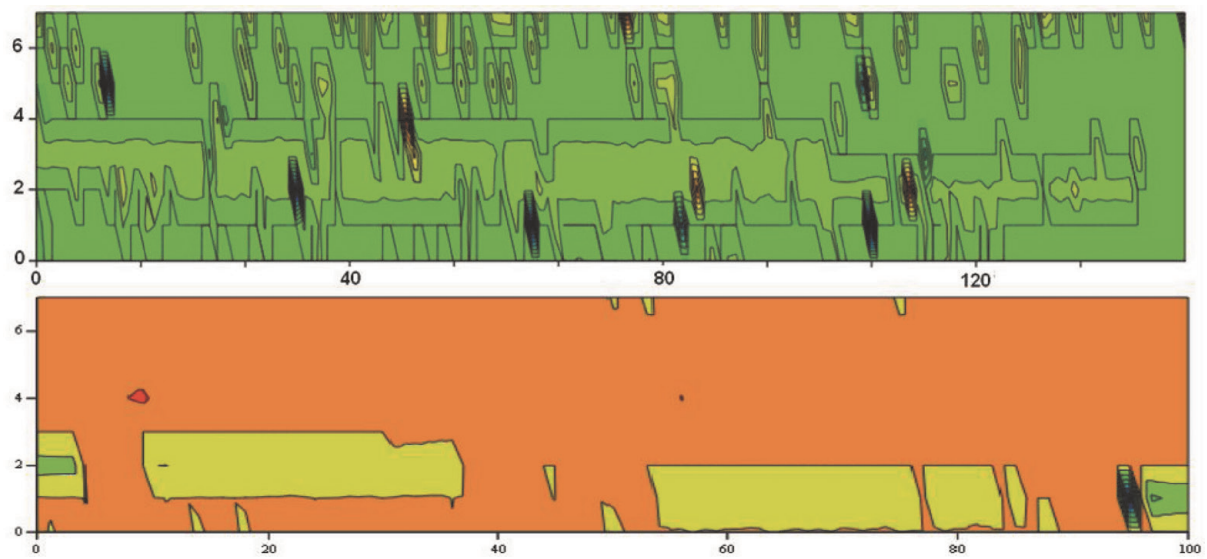
Figure 5. Comparison of CPD results for two welded joints: the hull penetrations (upper figure) and the control weld (lower figure). $SLS=3.944$.

Figures 5–7 (in the upper part of the drawings) show the results of CPD hull penetrations–potentiogram of the welded joint of the hull to the disk. The CPD measurement was performed by manual scanning (transducer KH18N10T) in the temperature of 23 °C. The x-axis shows the coordinate along the axis of the welded joint, and the y-axis shows the number of the measuring track. Scanning was performed along eight measuring tracks. Before making measurements, the surfaces of the welded joint were polished and cleaned using acetone.

To analyze the results, the lower part of the figures shows the potentiograms of the control welding joints taken from [12]. Fragments of the hull penetrations are shown in figure 8. The red line in the figure indicates the axis of the welded joint along which the scan was performed.

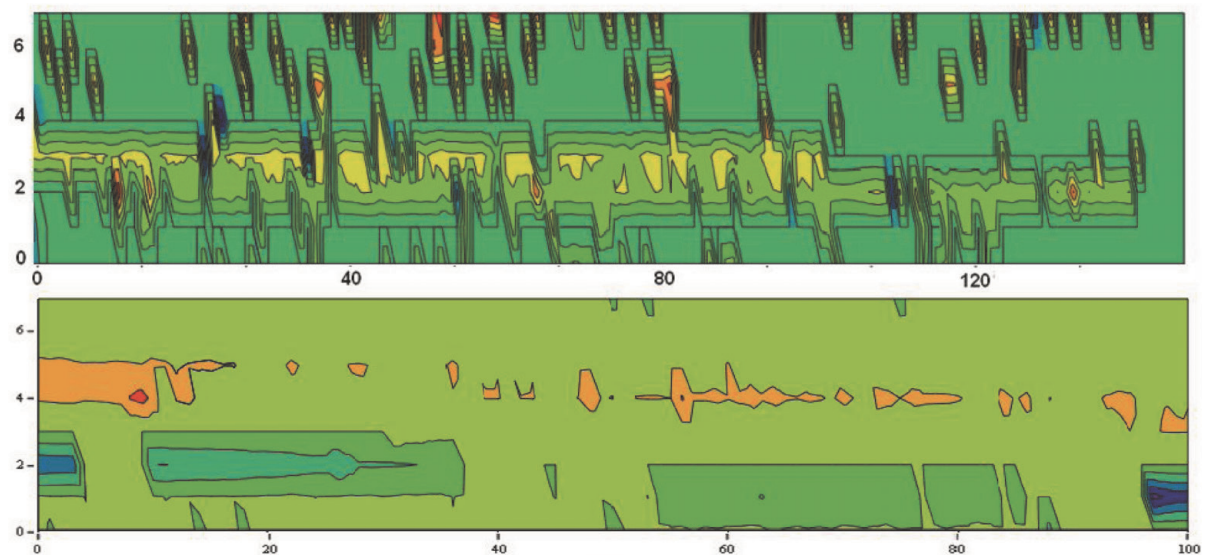
Figure 6. Same as in figure 5 with $SLS=4.531$.

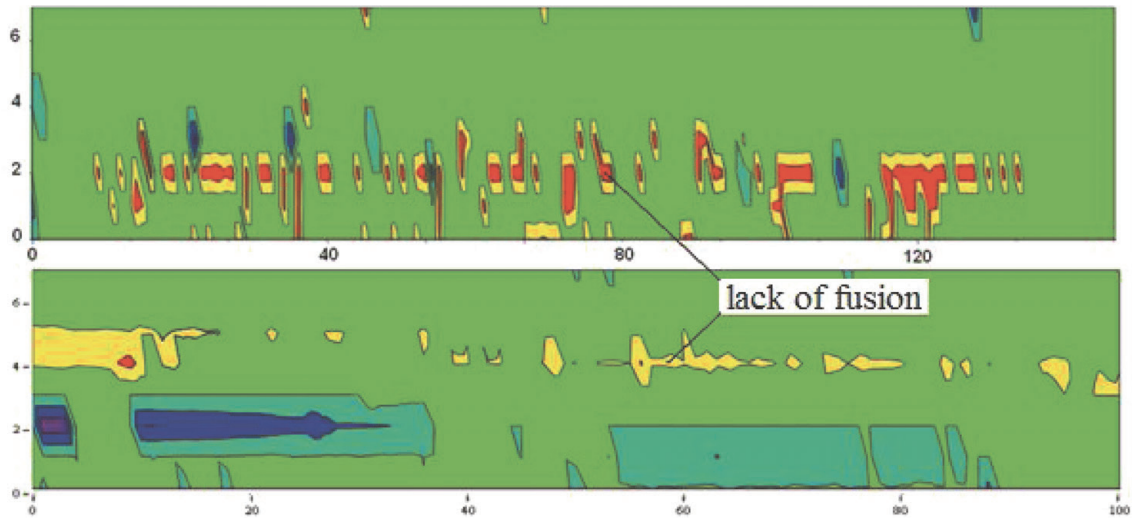
Figure 7. Same as in figure 5 with $SLS=4.857$.

From a comparison of the presented potentiograms for the hull penetrations and control welded sample, we can conclude that the root of the seam is incomplete, which is clearly visible in figure 7. Another reason may be the presence of contamination, foreign inclusions. At low SLS values, it can be also seen a numerous single structural inhomogeneities. In figures 5 and 6 internal lines of intersection of the cylindrical surface (body) with the plane (disk) are also visible.

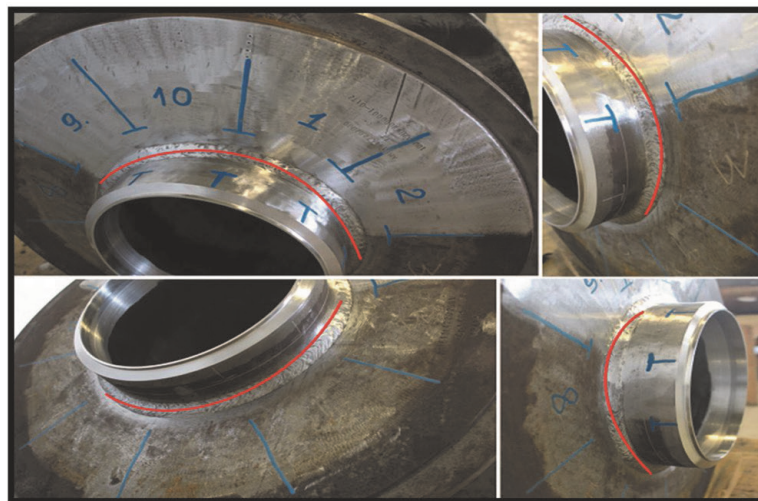
Figure 8. Fragments of hull penetrations. The red line indicates the axis of the welded joints of the housing with the disk.

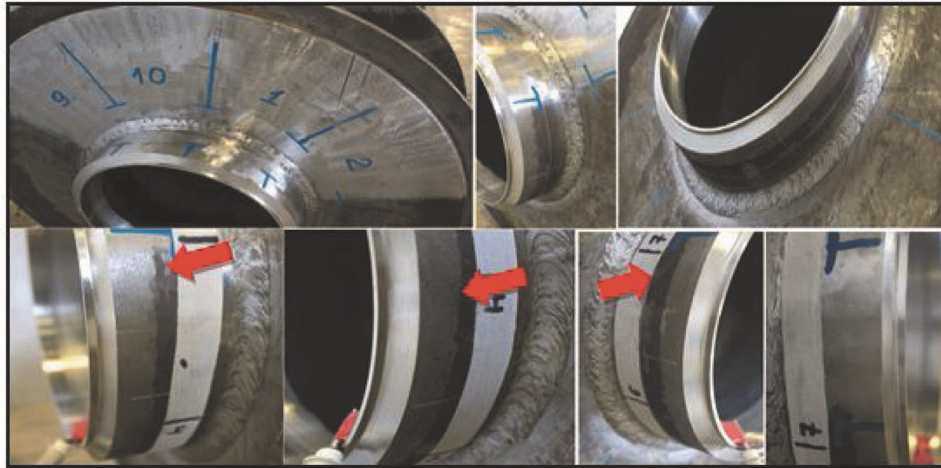
Figure 9. Fragments of the end part of the penetration. The red arrow indicates the outer surface of the surfacing, which was scanned by sensor.

The potentiograms in figure 10 show the distribution of inhomogeneities along the welded joint (width less than 30 mm). In figure 9 the surface that was scanned is indicated by red arrows.

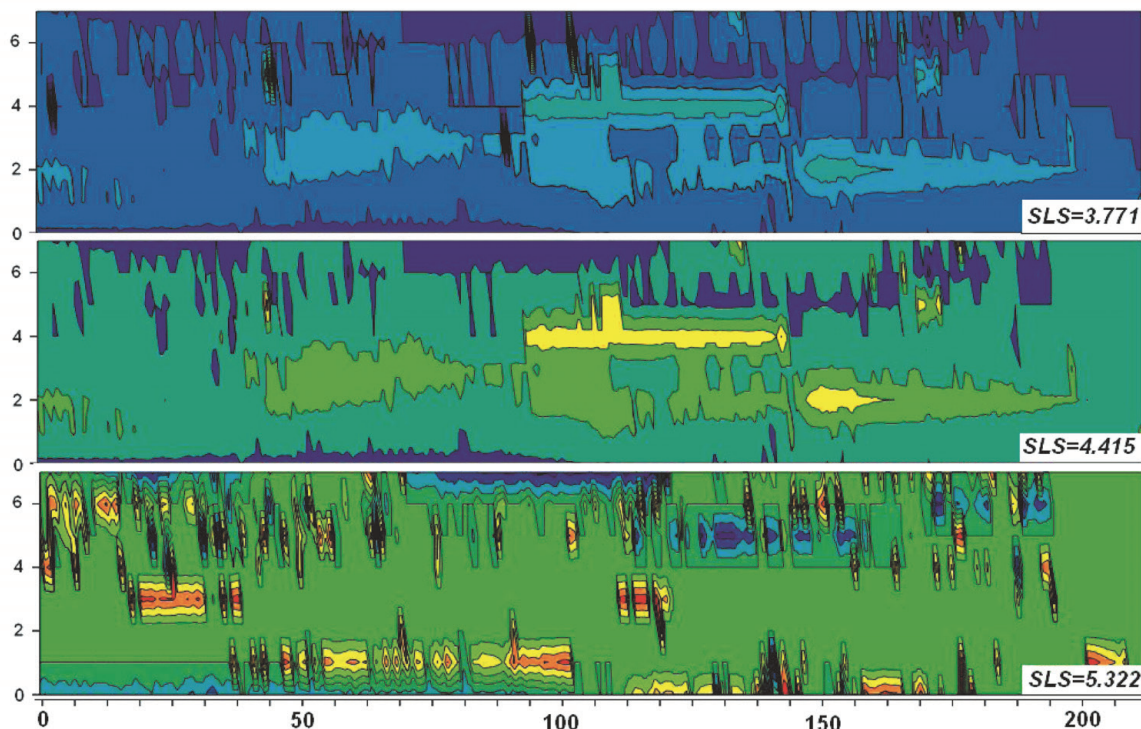
Figure 10. Potentiograms of the end part of the penetration body obtained for various structural signal levels.

By changing the limits of amplitude discrimination, it is possible to study the nature of the arrangement of structural inhomogeneities along the cross-section of the welding. Figure 10 shows that when approaching the inner surface, the inhomogeneities become more structured and less extended, which can be taken as an indicator of welding quality. The observed inhomogeneities occur mainly in the places where each subsequent roller is deposited on the previous roller and are probably associated with residual stresses of thermal origin. Another reason may be the occurrence of additional phases or small areas of formed slag and contamination. The width of inhomogeneities varies in a wide range: from a few millimeters to 10-15 mm or more (figure 10, upper potentiogram). The sources of formation of inhomogeneities structures in welding include:

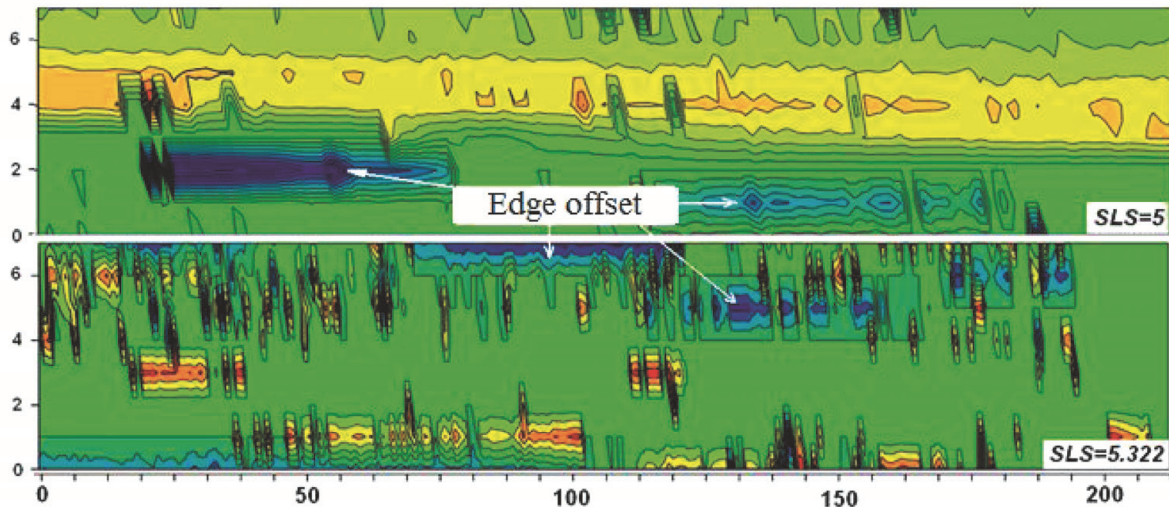
Figure 11. Comparison of CPD results for two welded joints: penetration body (lower figure) and control weld joint (upper figure) at $SLS=5.322$ and $SLS=5$, respectively.

Potentiograms show that the forming structure of the weld metal is characterized by various types of inhomogeneities. First, it can be concluded that inhomogeneities are present in both the first and the second welding layer. Second, it can be seen the areas with non-uniformity of “edge offset” type (figure 11). The reason for this may be non-melting along the contact boundary of the two welding layers (figure 8), or in the part where the first welding is adjacent to the surface of the casing of the penetration.
